# **Richmond Park, Crossings and Traffic Management**

## **Stage 3 Road Safety Audit Response Report**

On behalf of  
**The Royal Parks**

**Report Title:** Stage 3 Road Safety Audit Response Report **DRAFT**

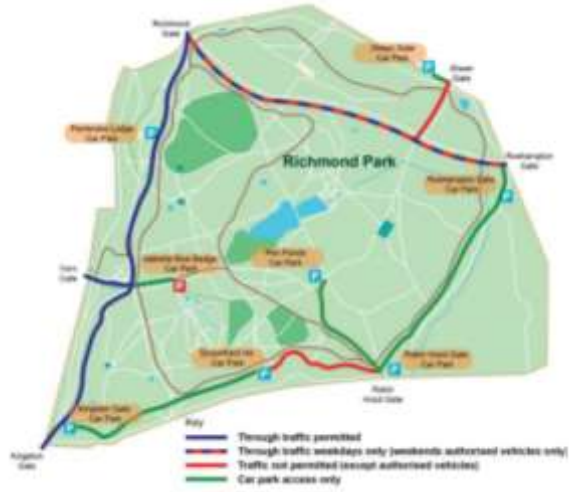
- 1.4 In August 2020, TRP launched a series of traffic-related trials across the five London parks to reduce the impact of cut-through traffic, improve the park visitor experience and open new spaces for park visitors to enjoy. Each of the parks has a unique set of trials, some are new and others seek to extend current access restrictions by vehicles. The trials were due to be in place for 18 mths, however due to Covid and with agreement of the surrounding boroughs and TFL, the trials remain in place. In summary the vehicle traffic restrictions in Richmond Park are summarised below and shown in the plan.

<p>Restrict all cut-through traffic between Broomfield Hill Car Park and Robin Hood Car Park;</p> <p>Close the vehicle link between Sheen Gate and Sheen Cross; and</p> <p>On weekends restrict all through-traffic between Roehampton, Sheen and Richmond Gates.</p>

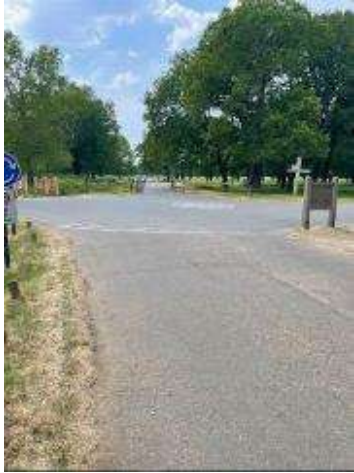
RSA problem number	RSA problem	RSA recommendation	Design Organisation response	Overseeing Organisation response	Agreed RSA action
<p>2.2 Problem</p>

<p>Faded lining at Robin Hood Gate roundabout</p>	<p>Location – Roundabouts at Roehampton Gate, Richmond Gate, Robin Hood Gate and Kingston Gate (drawings 003, 006, 008, 002)</p> <p>Summary: Overshoot collisions at roundabouts</p> <p>It was noted that at each of these roundabouts the advance roundabout signing was located very close to the circulatory and was partly obscured by the gate features (see photo in Problem 2.1). At the Robin Hood Gate roundabout, the give way road markings were also faded. Approaching users, especially cyclists might not be aware of the roundabouts ahead and might fail to slow down and give way to traffic on the circulatory, increasing the risk of collisions.</p>	<p>The roundabout ahead signs should be further inset into the approach arms, ensuring they are not obscured by the gate features.</p>	<p>The Design Team acknowledge that visibility to the roundabout warning signs are partially obstructed to approaching road users. The Design Team suggests an initial mitigation measure could be to use post extensions in their existing positions to increase the height of the sign face to improve visibility to the signs.</p> <p>However, we propose that a more detailed review on site would be required to determine if relocation of these signs is required and if so, to determine the most appropriate location and mounting height in each case. This would prevent inadvertently impacting other elements of the recently installed scheme or existing street furniture etc. The potential to combine this signage and signage recommended in 2.1 and 2.6 will be reviewed and detailed subject to a site visit.</p> <p>This existing condition of the road markings is separate to the recently installed scheme The Design Team do not manage TRPs highway maintenance/intervention but will bring this to their attention by issue of this report.</p>	<p>TRP would welcome a further assessment on both the size and positioning of the signs to ensure their visibility giving warning of the road hazard ahead.</p> <p>Road markings has been acknowledged and arrangements made for over marking.</p>	<p>Assess existing roundabout signage and adjust size, height and position as necessary to improve visibility, in conjunction with agreed action to Problem 2.6. Design subject to site visit observations.</p>

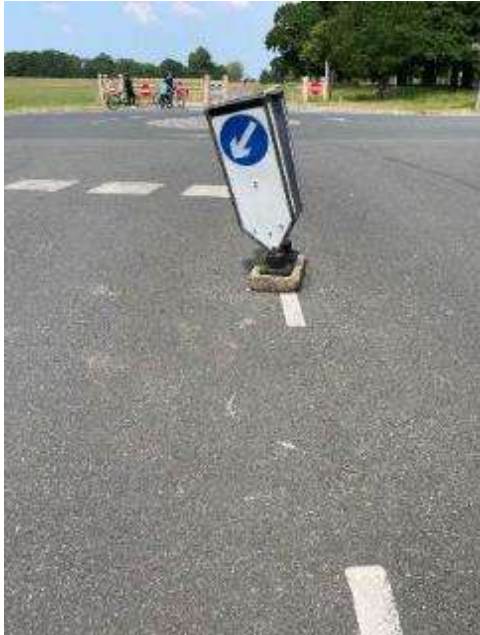
<p>2.3 Problem</p>

<p>Location – Sawyers Hill roundabout with Sheen Gate (drawing 004)</p> <p>Summary: Strike hazard</p> <p>At the southern arm of this roundabout there is a double-sided keep left bollard with 'authorised vehicles only' on the reverse which is leaning over and is located in a solid concrete block. This could present a strike hazard to all road users, especially for cyclists when in dusk conditions where visibility is lower.</p>	<p>The sign and concrete block should be relocated out of the carriageway.</p>	<p>This existing element of street furniture predates the recently installed scheme and is not fundamental to it.</p> <p>The Design Team acknowledge the potential risk identified by the Audit Team and will liaise with TRP to understand how long this sign has been insitu and if there is a history of collisions associated with it.</p> <p>That said, the 'Keep Left' sign is not required and the 'Restricted Access' sign(s) to TSRGD Diag. 619 could be installed on the adjacent verge negating the need for a sign in the carriageway.</p>

<p>Sign Diag. 619</p> <p>The roundabout markings are currently bold and there is a roundabout symbol sign in the verge, which describe the presence of the roundabout to all users.</p>	<p>TRP acknowledge the sign is not best positioned for the reasons highlighted. The keep left arrow is not required but a sign to reinforce the message only authorised vehicles is still required.</p> <p>TRP have arranged for the current sign to go.</p>	<p>Sign to be removed by TRP. TRP to determine if additional 'Restricted Access' signs are required in adjacent verge to enhance existing signage.</p>

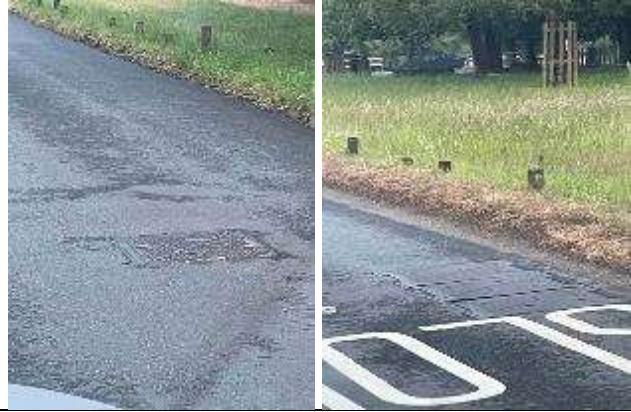
RSA problem number	RSA problem	RSA recommendation	Design Organisation response	Overseeing Organisation response	Agreed RSA action
<p>2.4 Problem</p>

<p>Location – Queens Road approach to Richmond Gate</p> <p>Summary: Skidding and loss of control collisions for two wheeled vehicles.</p> <p>On this approach there were two sets of service inspection covers which appeared to be worn and polished located in the primary riding position for cyclists and other two wheeled vehicles. These could have poor surface friction levels especially in wet and icy conditions, increasing the risk of skidding and loss of control collisions.</p>	<p>The worn covers should be replaced with high friction covers.</p>	<p>This existing element of street furniture predates the recently installed scheme and The Design Team do not manage TRPs highway maintenance/intervention but will bring this to their attention by issue of this report.</p> <p>However, the Design Team acknowledge the potential risk identified by the Audit Team, especially when considered in the context of disproportionately high volumes of 'sporting' cyclists travelling at relatively high speeds. The skid resistance of these covers should be assessed and replaced with high friction versions, if found to be deficient.</p>	<p>TRP have requested for these to be changed via our term facilities contractor. Ownership and responsibility to be determined. Added to our Road and Footpath Tracker to review progress.</p>	<p>TRP to investigate ownership and responsibility for these covers and request their replacement.</p>

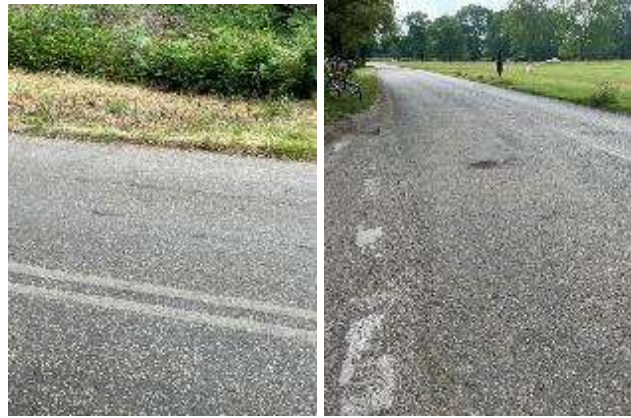
<p>2.5 Problem</p>

<p>Location – Broomfield Hill heading south to car park.</p> <p>Summary: Skidding and loss of control collisions for two wheeled vehicles.</p> <p>On this fast downhill section, where cyclist speeds were high, there were some highway defects, including some raised patch work and potholes. These could destabilise cyclists and two wheeled vehicles, increasing the risk of loss of control and the rider being ejected from their bike and sustaining injury.</p>	<p>The highway defects should be repaired ensuring a smooth flush carriageway surface.</p>	<p>This existing road condition is separate to the recently installed scheme The Design Team do not manage TRPs highway maintenance/intervention but will bring this to their attention by issue of this report.</p> <p>However, the Design Team acknowledge the potential risk identified by the Audit Team, especially when considered in the context of disproportionately high volumes of 'sporting' cyclists travelling at relatively high speeds. The road condition should be inspected and repaired as necessary.</p>	<p>TRP have requested for these to be actioned via our term facilities contractor. Added to our Road and Footpath Tracker to review progress.</p>	<p>TRP to action suitable repairs via maintenance contractors.</p>

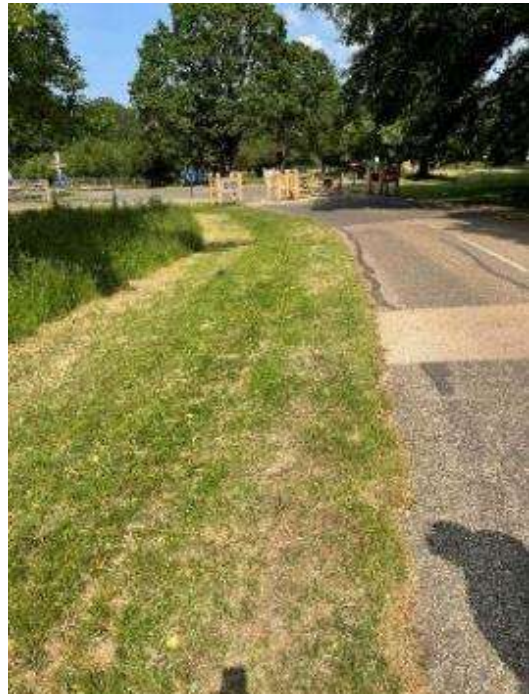
<p>2.6 Problem</p>

<p>Location – Broomfield Hill heading north to Robin Hood Gate roundabout (Drawing 008)</p> <p>Summary: Speed related collisions at gate and roundabout</p> <p>At this steep downhill section of the route, cyclists were observed travelling at high speed through the gate and into the roundabout. This could increase the risk of speed related collisions with the wooden gate feature and other users in the circulatory.</p>	<p>Additional signing and 'Slow' road markings should be installed to encourage lower speeds at this location.</p>	<p>It is unclear from the Audit Teams photo to determine if the proposed 10mph roundels have been installed. If installed as per the design and in combination with the other visual cues such as the existing roundabout signage and recently installed gateway feature/signage, The Design Team believe these to be sufficient to impart the message to slow down and give way ahead. That said, additional 'SLOW' road markings west of the first bauxite banding feature would further enhance this message.</p> <p>However, we propose that a more detailed review on site would be required to determine if additional signage is required and if so, to determine the most appropriate location and mounting height in each case. This would prevent inadvertently impacting other elements of the recently installed scheme or existing street furniture etc. The potential to combine additional signage and potential signage recommended in 2.2 will be reviewed and detailed subject to a site visit.</p>	<p>Speed of cyclists is a concern in approaching this roundabout, pedestrian crossing and equestrian crossing. Therefore, a site of multiple hazards. Would like to see further signage and road markings considered for this section to help slow the speed further.</p> <p>Also, to consider a different road surface to help with breaking.</p>	<p>Provide additional signage and road markings to enhance existing warning to slow for gate and roundabout ahead, in conjunction with Agreed Action to Problem 2.1. Design subject to site visit observations.</p>

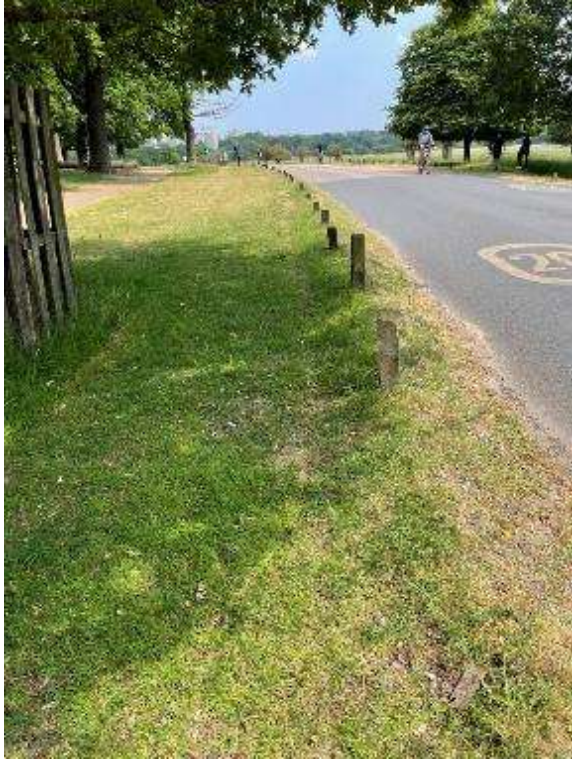
RSA problem number	RSA problem	RSA recommendation	Design Organisation response	Overseeing Organisation response	Agreed RSA action
2.7 Problem

<p>Location – General: throughout park</p> <p>Summary: Injury hazards for errant cyclists</p> <p>Throughout the site small wooden stakes inserted into the verge are being used as parking deterrents on both sides of the carriageway. These could be hazardous in the case of errant cyclists who fall off their bicycle and into the grass verge area. If they fall onto these potentially sharp objects, they could sustain severe injuries.</p>	The wooden stake features should be reviewed and replaced with alternative features such as passively safe products, especially at locations where cyclists' speeds are likely to be higher.	<p>This existing element of street furniture predates the recently installed scheme and is not fundamental to it. The Design Team do not manage TRPs highway maintenance/intervention but will bring this to their attention by issue of this report.</p> <p>However, the Design Team acknowledge the potential risk identified by the Audit Team, especially when considered in the context of disproportionately high volumes of 'sporting' cyclists travelling at relatively high speeds.</p> <p>The Design Team believe these posts have been installed to deter verge side parking which we understand has historically both directly and indirectly increased the risk of highway maintenance and highway safety issues.</p>	<p>Current Risk Assessment acknowledges these as a hazard on hill sections and as such these have been removed.</p> <p>TRP further acknowledge this recommendation to take this further and are looking at a plan to remove more of these bollards where risk of illegal parking is low (Sawyers Hill as its closed to motor vehicles at weekends) Then look at alternative landscaping i.e. mounding, ditches/swales as a future replacement for the bollards and ensuring we protect the verges from illegal parking.</p>	Please refer to Overseeing Organisations Response.
